Luckens Reserve

Location:	Marina View Drive, West Harbour
C o n t e x t :	Urban / Residential / Coastal
Description:	Local Multi Use / Recreation Reserve
Area:	57,678.58 m ²
Legal Description:	LOT 1 DP 52529 LOT 235 DP 99460 LOT 3 DP 57411 LOT 33 DP 177024
Entry:	
Visibility	Good
Legibility	Clear
Accessibility	Good
Connectivity	Good - Pedestrian
Number	-
Signage	-
Carparks:	30 – 40
Boundary:	Enclosed - Fences
Paths:	
Type	Concrete - exposed metal
Condition	Good
Width	1.5 - 2.0m
Connection	Good – Indirect
Buildings:	Toilet block, visible to playground and road
Seats:	2 recliner slab seats at playground, 2 picnic tables.
Bins:	3 metal
Lights:	No
Playground:	2 swings, tunnel slide, slide, climbing, overhead tunnel
Condition	Good
Security:	
Outside	Good from west, Ok from east
Inside	Ok - compartmented
Entrapment Potential	Possible in planting areas
Contour:	Moderate / Gentle

Waitakere City Council Site Visit

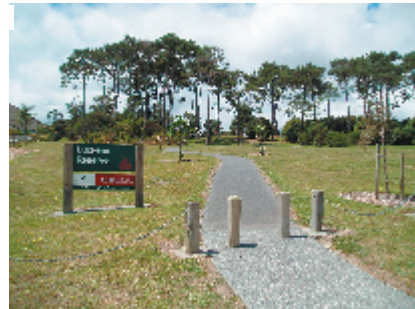
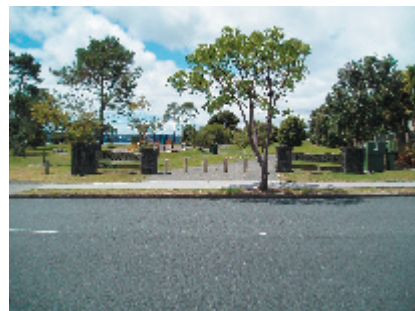
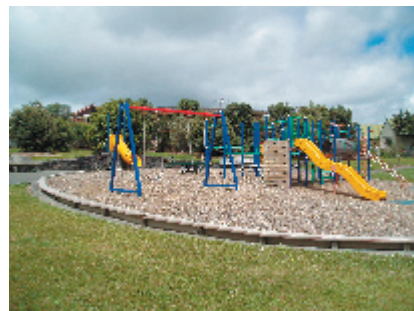
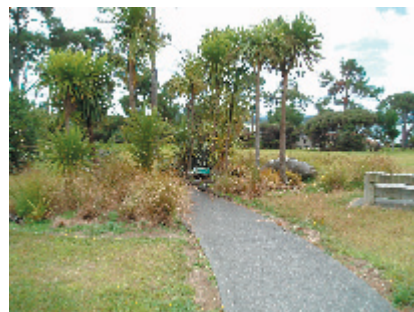
- The legibility and accessibility are good.
- Good playground, good visibility from within the park, not so clearly visible from the exterior, some views from the road.

- Park furniture is in varying degrees of decline. Wooden park benches are deteriorating, connections are loose, some evidence of temporary repair.
- Poor legibility to the coastal esplanade area, few coastal signifiers. Reasonable gradient to 'beach', potential for development, particularly views over the harbour. Many weeds species present on cliffs. No feature at destination. Isolated.

- Central planted area offers many areas of entrapment and potential hiding places.
- Evidence of trees having died and been removed and not replaced, particularly from the west boundary to Marina View Drive.

- "Trees for Babies" area needs attention, establishment of weeds and poor plant performance. Ceramics historical area needs a tidy up, damaged seat.
- North boundary to houses in area which is fenced requires tidying, scruffy weeds establishing.

Look into maintenance of park furniture, life expectancy, and possible replacement, renewal programme.

Develop plan for removal of existing feature pine trees and provision of new trees to retain the existing character.

This will need to be addressed relatively quickly given the anticipated life expectancy of the trees.

More closely monitor installations such as 'Trees for Babies', and commemorative plaques etc.

Evaluate the merits of improving access to the coast and improving the beach interface.

Generally tidy areas of planting and development of planting programme for the coastal edge planting.

Develop areas of the park which are damp with appropriate planting. Look into replacement tree planting where the trees have been removed, with more suitable species.
