*Misleading Signs*

### *Non-compliant Signs*

## Conclusions

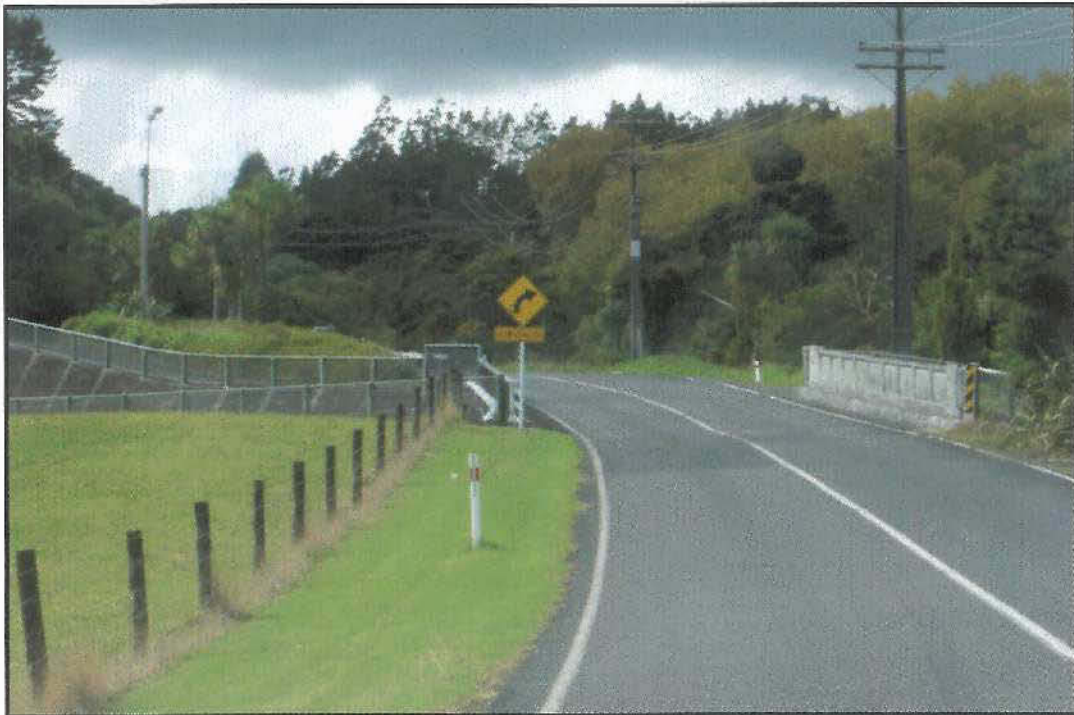
Photograph E: Sign indicating right hand curve when vehicles in fact must make a relatively sharp left turn before turning right

- A small number of signs have been identified on all three routes that are incorrectly located and may give drivers misleading or incorrect information. These signs should be removed or replaced; however, apart from these signs, the overall signage along the routes is considered appropriate.

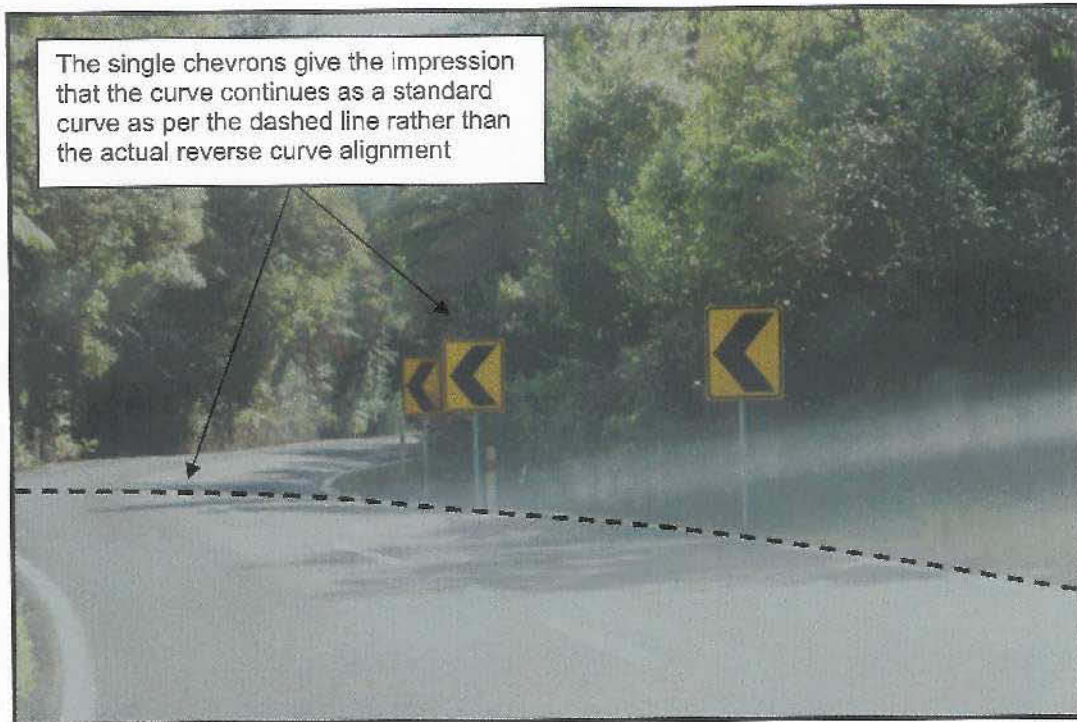
Photograph F: Single chevrons give drivers the impression of a standard curve rather than a reverse curve

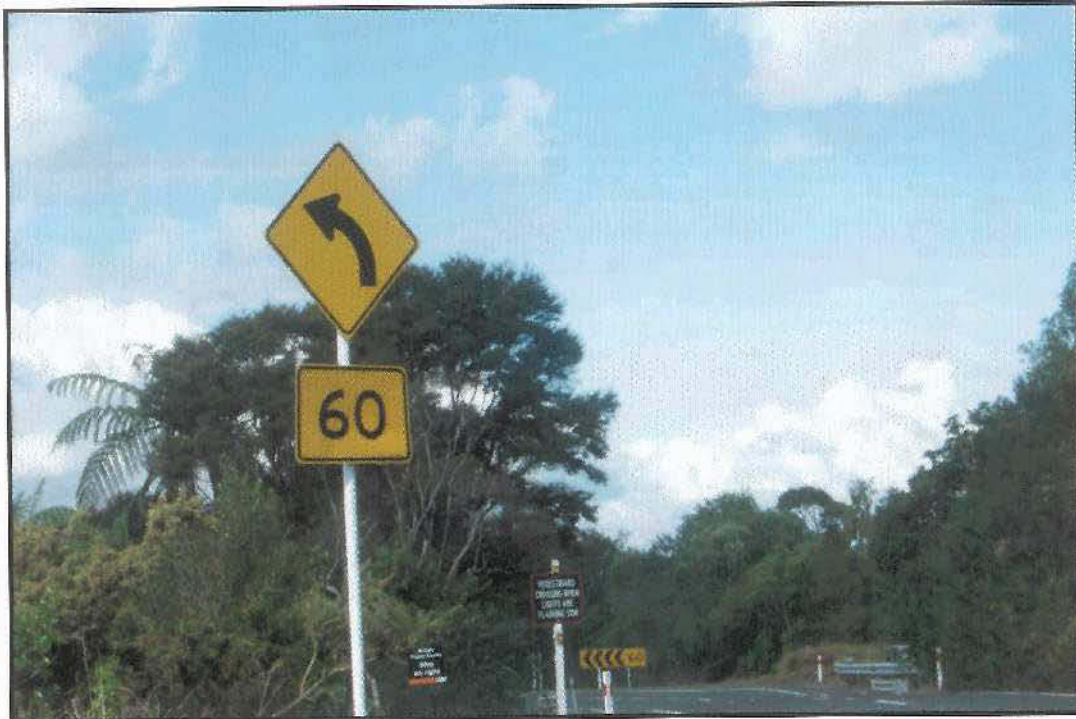
It is also noted that a number of the bends on the roads have curve advisory speeds with multiples of ten (i.e. 40, 50, 60). The Manual of Traffic Signs and Markings (MOTSAM) specifies that advisory speeds should end with a five (i.e. 45, 55, 65) and hence these signs do not strictly comply with MOTSAM.

Photograph G: Advanced curve warning and horizontal curve chevron with non-standard advisory speeds of 60 kph.

The costs associated with correcting non-compliant signs are not considered justified, mainly because the technical non-compliances are not likely to cause a significant safety issues. However advisory speed signs with multiples of 10 kph should be corrected when any new advisory speeds are installed or replaced.
