old new lynn hotel  
new lynn  
heritage feasibility assessment

for  
waitakere city council  
henderson

march 2008

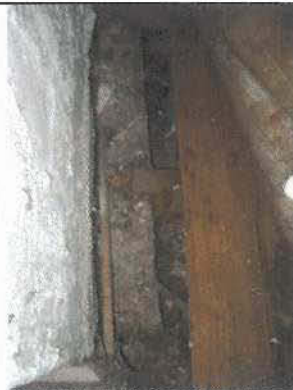
Rotten floor joists in hallway

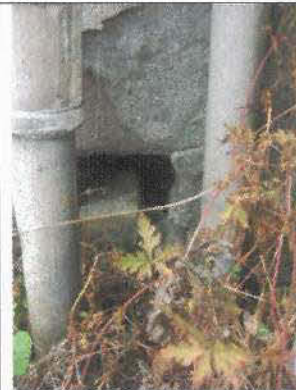
Missing bricks at base of north west corner

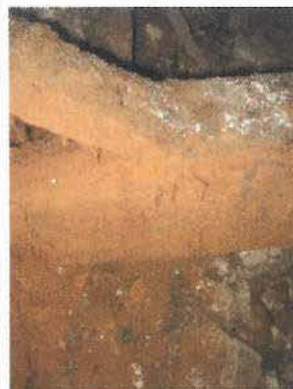
Floor joists on ground in hallway

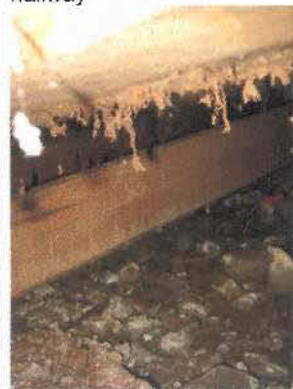
Ground level at back of building in hallway

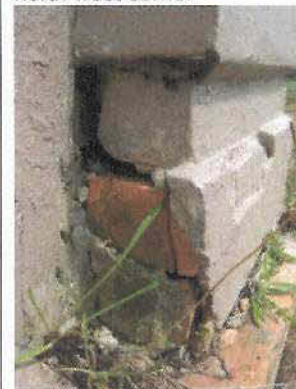
Cracking and spalling of brickwork at base of north west corner
