2.3 Site 2- Piha Road from Karekare Turnoff to Te Ahuahu Road (both sides of road)

2.4 Site 3 - Piha Road from Te Ahuahu Road to Piha Lookout (both sides of road)

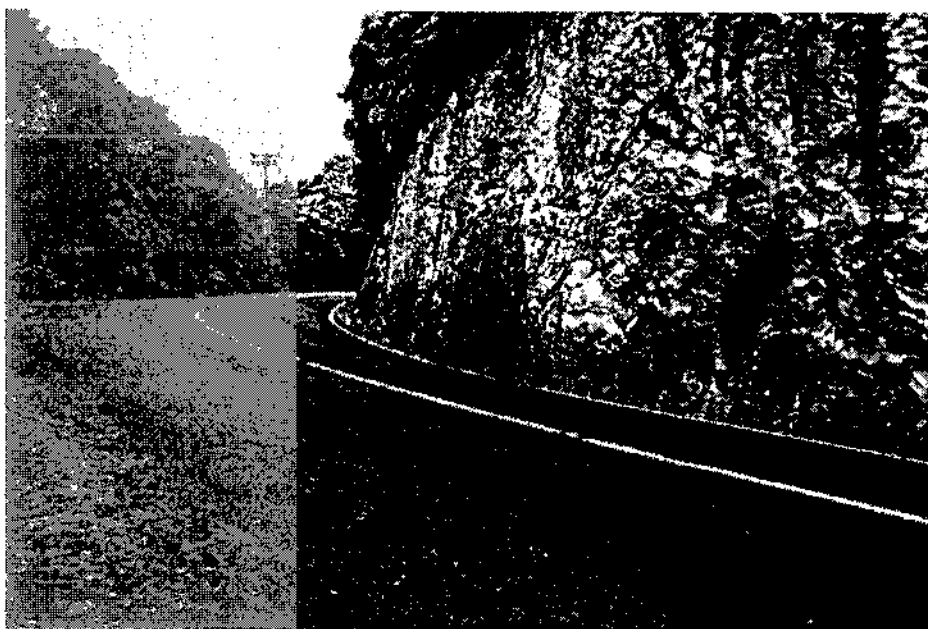
Fig. 2.6: Tall embankment at top of Piha Hill.

From Te Ahuahu Road to Piha Lookout gorse is generally patchy on the east side of the road, increasing in density towards the lookout. The weed is patchy along the western roadside but forms 60-80% cover within 10-20 m of the carriageway in places. Piha Road has been cut into a c.10 m

high sandstone embankment at the top of Piha Hill (Fig. 2.6). Gorse has not yet colonised the face of this embankment, and is not expected to do so for many years given the hard nature of the substrate. However, it forms a thin margin against the native shrub association on top of the embankment. The substrate throughout most of Site 3 consists of flat or moderately sloping shallow, clay-based soil. Areas below the embankment are exposed to strong westerly winds.

- Dense gorse infestations along Piha Road from Te Ahuahu turnoff to Piha lookout (Site 3, refer fig. 2.2). In these areas roadsides are flat to moderately sloping, with dry clay soils. Gorse cover is patchy, and increases in density towards the lookout, reaching 60 - 80% cover to 10 - 20 m of carriageway between the steep embankment and the lookout.

- Sparse gorse infestations along Piha Road from Te Ahuahu turnoff to Piha lookout (Site 3, refer Fig. 2.2).

Gorse forms scattered patches within first 2 - 5 m of carriageway in several places (not mapped) along this section of road. Planting is

recommended in sites where there is no existing forest margin within 10 m of the carriageway.
