**PIHA ROAD  
GORSE MANAGEMENT PLAN**

JULY 2004

**Waitakere City Council**

**Kingett Mitchell Limited**

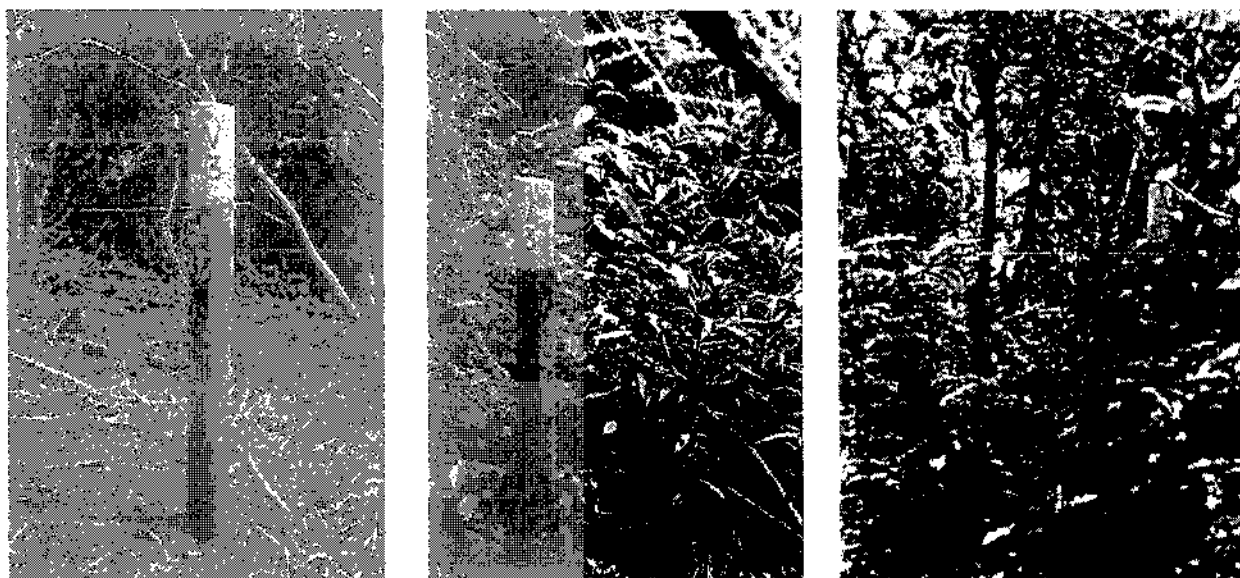
**Fig. 1.2: Hinewai gorse suppression trial showing sequence of native regeneration after 5 years (copied from Wilson 1994).**

best approach adopted in natural areas became the exploitation of its role as an early successional 'nurse' plant and allowing native plants to regenerate through, and outshade it (e.g. at Hinewai (Wilson 1994) Fig. 1.2). The benefits to this approach of gorse control in natural areas are substantial, given that it bypasses the need for intensive herbicide use or manual labour. However, some aspects may yet need refining, especially in dry coastal environments where gorse is most competitive as a weed.

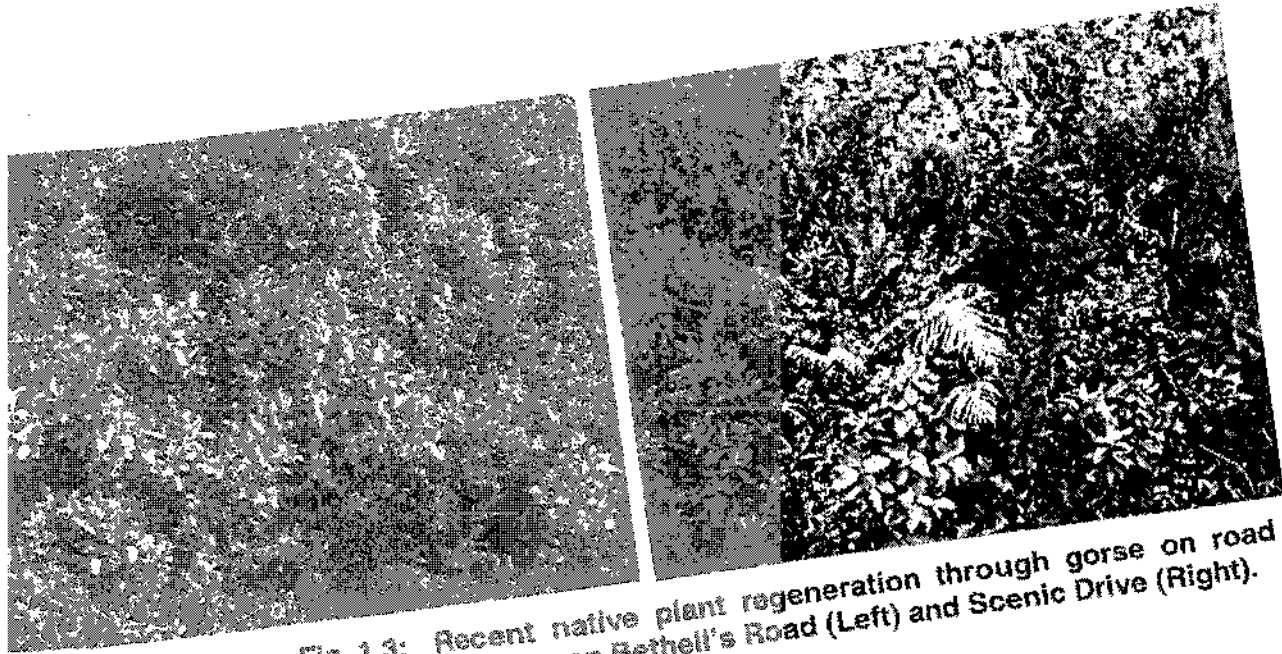
Fig. 1.3: Recent native plant regeneration through gorse on road cuttings on Bethell's Road (Left) and Scenic Drive (Right).

After approximately five years, gorse appears to be playing out its role as a nurse plant throughout most WCC administered roadsides and reserves in a predictable and ecologically beneficial way (Fig. 1.3). It is easily outgrown by secondary native vegetation on moderately moist flat or sloping terrain, and is often the first species to establish on vertical road cuttings, providing favourable microsites for native species. Gorse typically colonises the base of road cuttings where soil moisture collects. Regeneration seeded from the native plant communities on top of the cutting, and native/ gorse assemblages at the base of the cutting, gradually fills the driest central zone until the entire surface is covered.

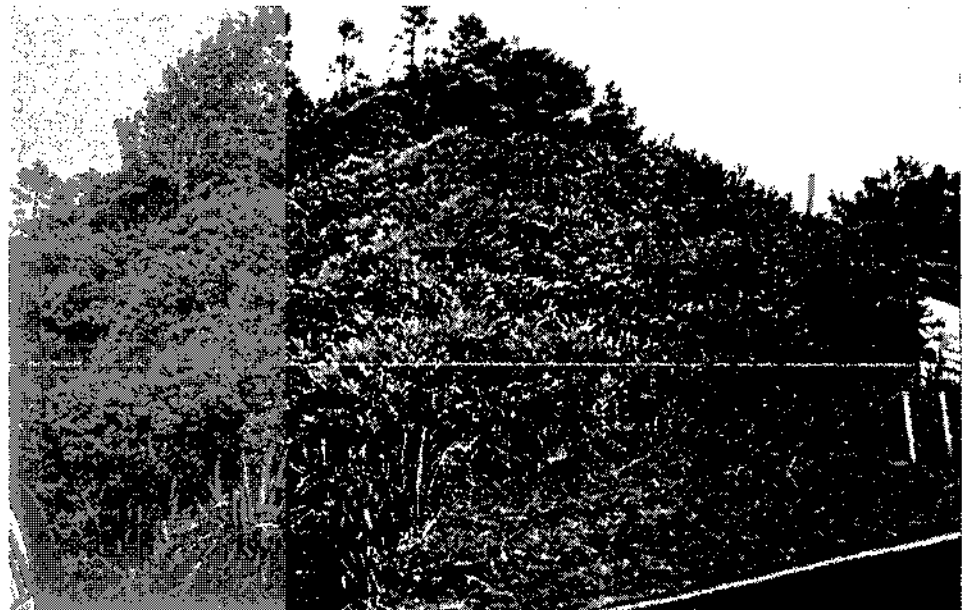
Fig. 2.1: North Western Embankment of Karekare Road Turnoff.

Gorse is prominent on the north western embankment of the Karekare Road turnoff itself, where it forms a c. 65 % cover with interspersed manuka and other native shrubs (Fig. 2.1). The substrate is clay-based, moderately sloping, clay-based soil. The site has a north-eastern aspect and is therefore relatively sheltered from westerly winds.

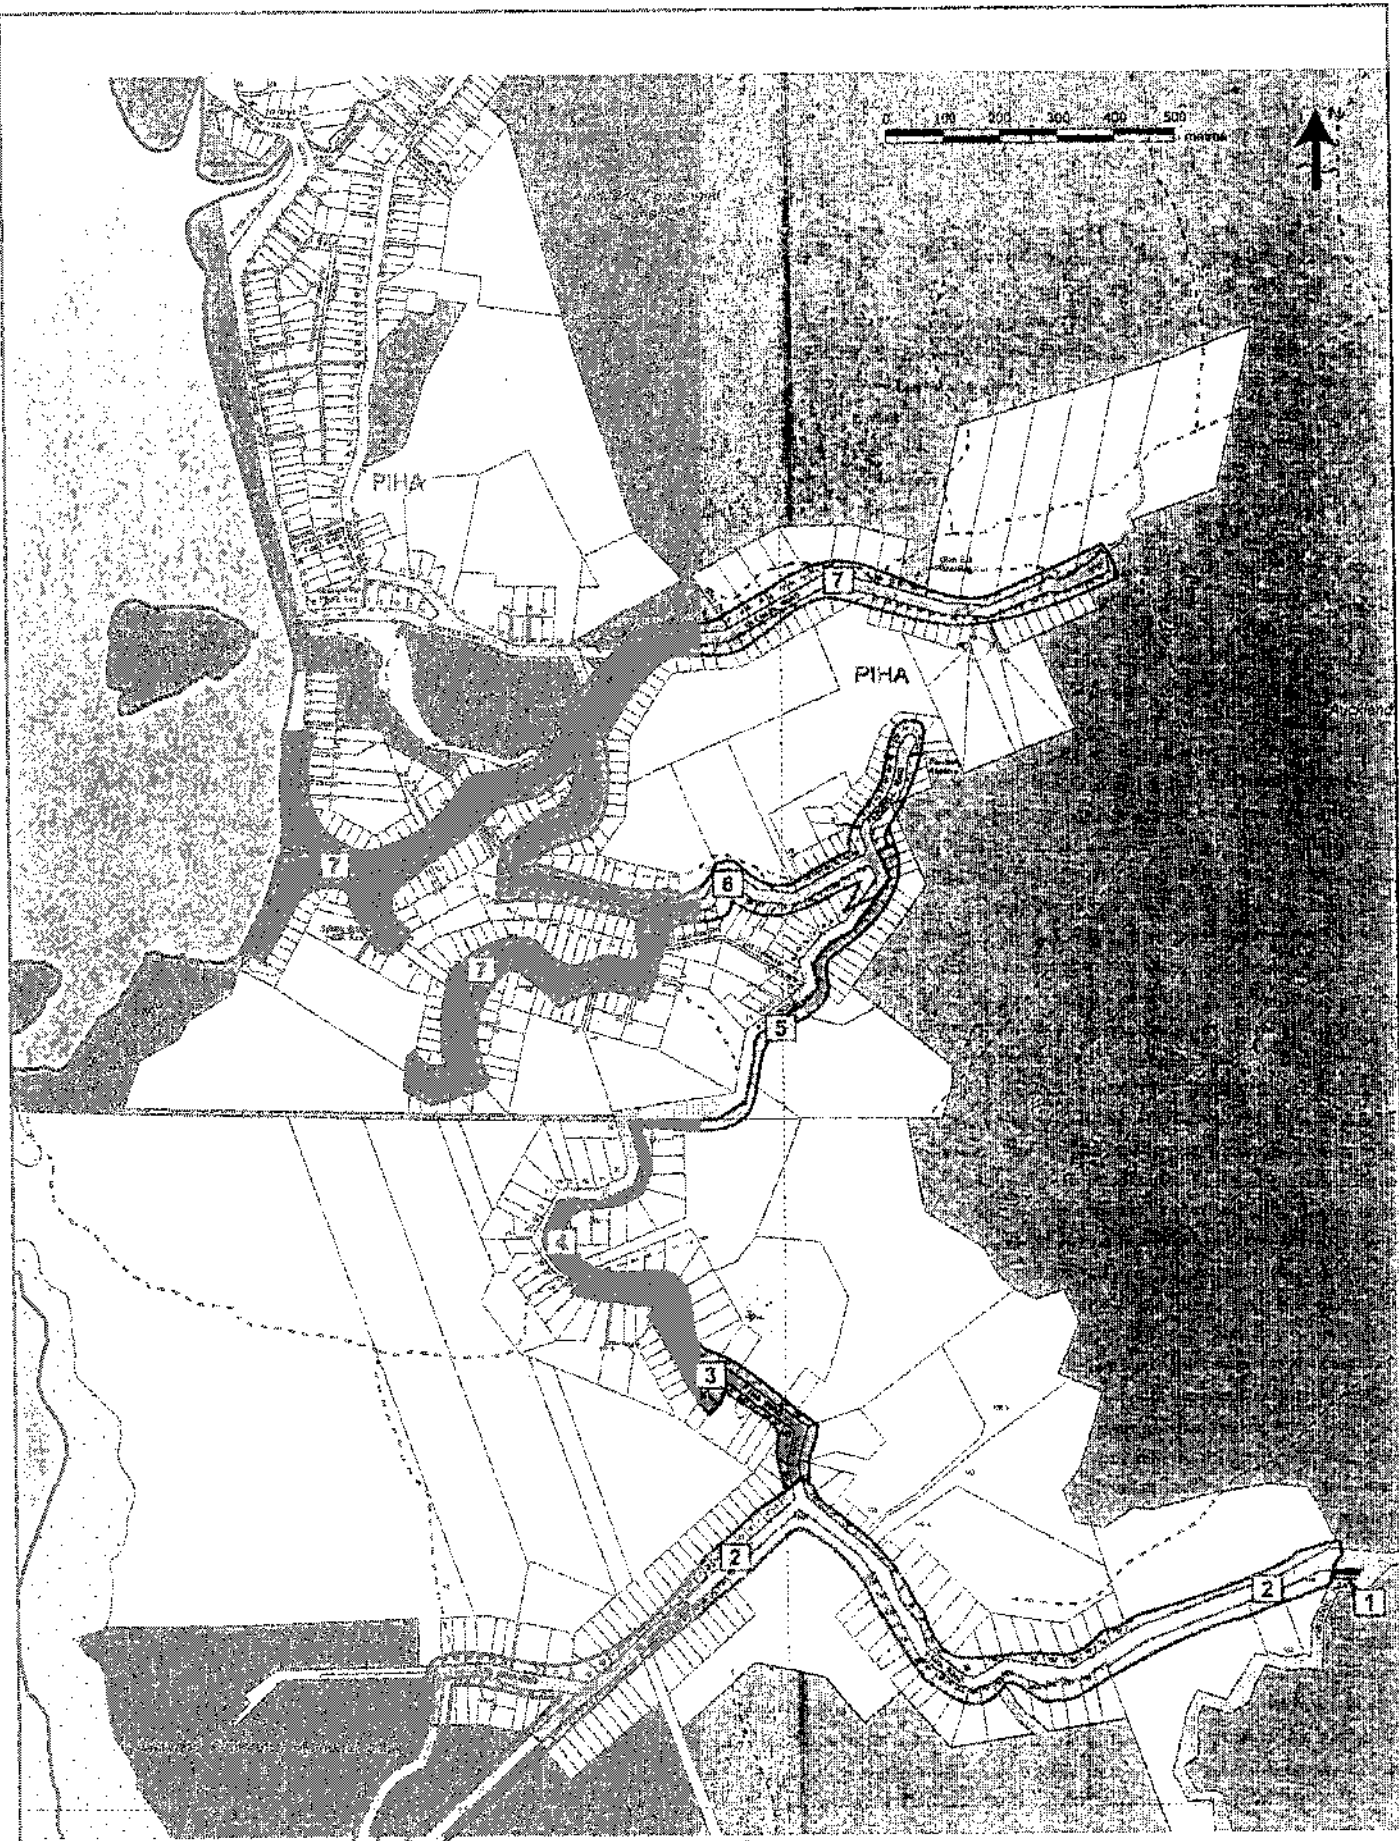
FIGURE NO. 2.2

For the purpose of this management plan sections (gorse management sites) of Piha Road and side roads have been distinguished by the nature of the site and local gorse population characteristics (Fig. 2.2). The following description of gorse populations at Piha is presented in accordance with these gorse management sites.
