Case study: University of Auckland, School of Engineering greenroof plants

Case study: Waitakere Civic Centre Greenroof plants

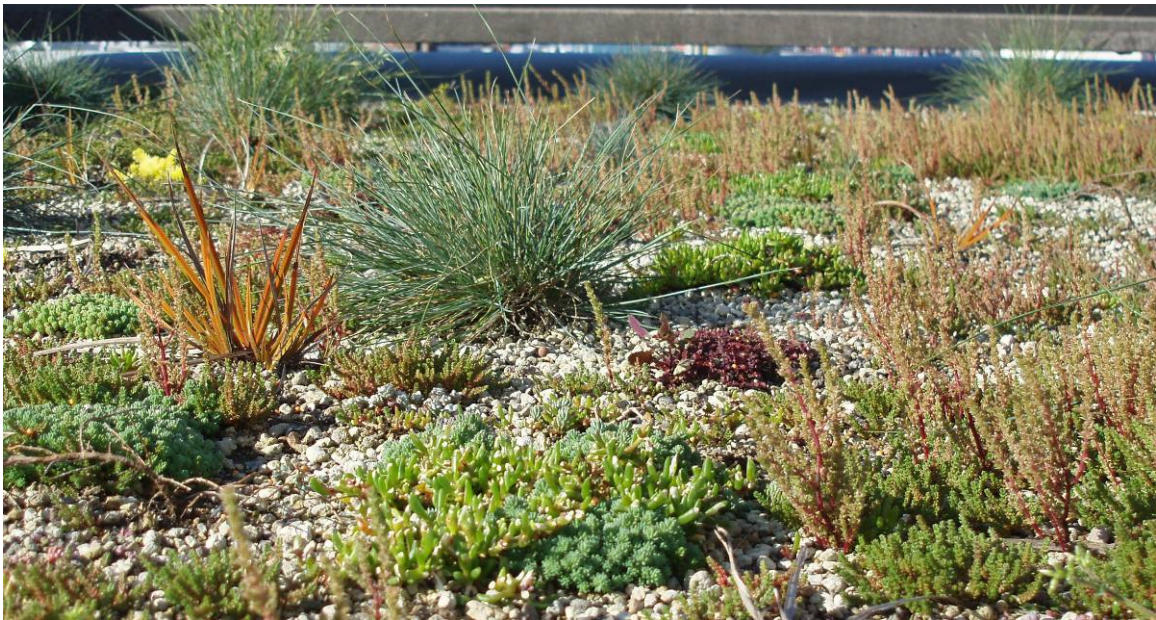
Fig. 1 Native plant section of Plot one, spring 2007, about one year after establishment, showing *Crassula sieberiana* (right and background) with iceplant (light green succulent in foreground), NZ iris (orange spikey foliage on left) and fescue (blue tussock grass in the centre). Two sedum species have invaded the plot (bright yellow *Sedum mexicanum* upper left and a cultivar of *Sedum album* - the blue succulent within iceplant in centre foreground and left)

The greenroof was constructed in late spring 2006. After one year *Disphyma australe* and *Crassula sieberiana* have established large numbers of new seedlings across most of the roof, including areas where they were not originally planted. *Crassula* may not provide year-round cover. We wait to see if the new iceplant seedlings will survive summer. Vegetation data quantifying performance after the first year has yet to be analysed, however, species that have highest survival are iceplant, crassula, fescue, sand-dune coprosma and NZ iris. Some individuals of all plant species survive on the roof - no species has failed entirely, however, survival appears to be highest on areas with more shade and deeper substrate (plots are either 50 or 75 mm depth).

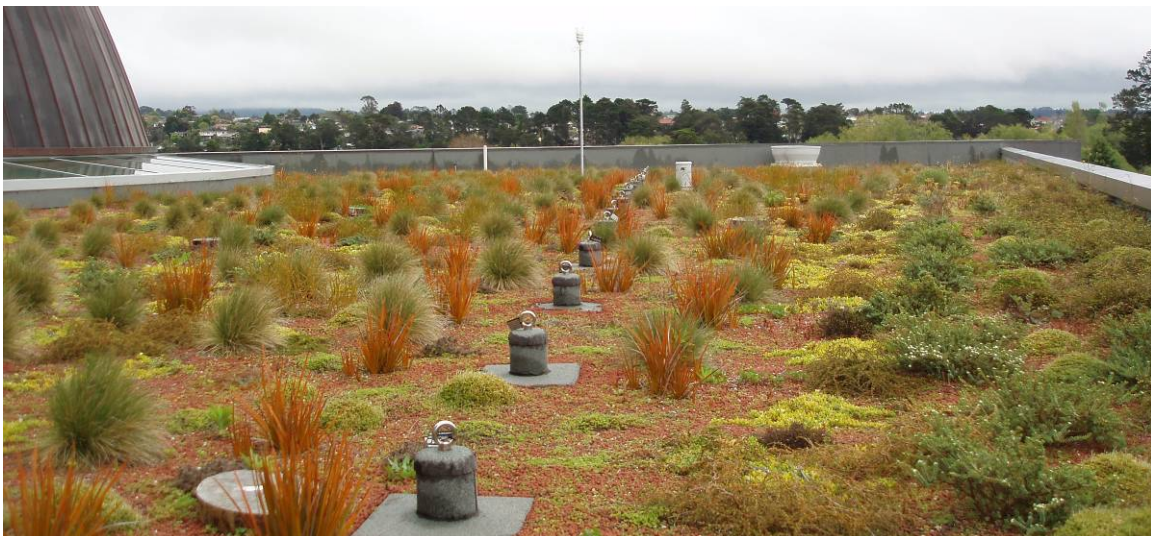
Fig. 2 Waitakere greenroof in spring 2007, just over one year after establishment. A 1 to 2 m wide strip of deeper substrate along the left hand side is planted in *Muehlenbeckia* species, white-flowering NZ daphne (*Pimelea prostrata*) and rounded mounds of *Leptostigma setulosa*. The remainder of the roof is visually dominated by the tall spikey fescues (blue tussocks, *Festuca coxii*) and NZ iris (orange, *Libertia peregrinans*), and lime-green iceplant.

The greenroof was constructed in winter 2006. After one year *Disphyma australe* has established large numbers of new seedlings. Vegetation data quantifying performance after the first year has yet to be analysed, however, species that have highest survival are iceplant, fescue, sand-dune coprosma and NZ iris. Some individuals of all plant species survive on the roof, however, the diversity and cover of plants is highest on areas with deeper substrate (100 to 150 mm depth); two areas with thin substrates (c.70 mm depth) have had moderate to high plant mortality. Mercury bay weed, Selliera and Leptostigma died back in summer but have spread dramatically since autumn rains have fallen - these species may be best suited to deeper substrates or areas with afternoon shade.
