The State of our Land

TAIPARI STRAND

Restoration of a contaminated site

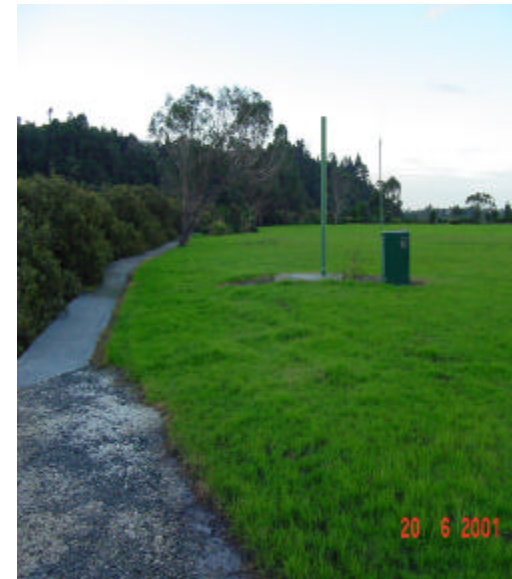
The picture clearly shows the surface profile of the closed landfill/reserve and the proximity of the pump station to the seawall/mangrove of the coastal marine area.

Taipari Strand is located on the southeastern edge of Te Atatu Peninsula on the east bank of Henderson Creek. Between 1963 and 1974, refuse including domestic, commercial and industrial wastes were dumped directly onto marine sediment. No protection measures were installed to avoid surface water contamination or contaminants entering into the groundwater beneath the landfill. As a consequence, contaminants entered into the ground and seeped onto the mudflats of Henderson Creek. The contaminants were flushed out to sea and dissipated by seawater, but at low tide the contaminants were prevented from entering into the sea, and instead remained in the mudflats, endangering the estuarine ecosystem.

To remedy the situation the Aftercare team installed a collection system to contain contaminants entering into the groundwater. A pump station was installed to pump contaminants into a sanitary sewer some 100 metres away at periods of low tide. The site was then recapped to make the landfill secure, and to prevent future contamination of surface water. The surface of the landfill was also re-contoured to enhance stormwater run-off and to make the area more attractive. Remedial works were completed in September 1998.

The total effect of the project has been to make a degraded environment more attractive. The landfill is now actively managed to ensure that contaminants enter the creek at a rate and time compatible with the tidal flushing of Henderson Creek. The area is now safe for recreation and an asset to the community.
