In the Environment Court**ENF 13/98**Under the **Resource Management Act 1991 ("the Act")**In the matter of **an application for enforcement orders under section 314 of the Act**Between **Waitakere City Council**

Consent Order

Revegetation and Weed Management Plan

Earthworks Engineering and Works Plan

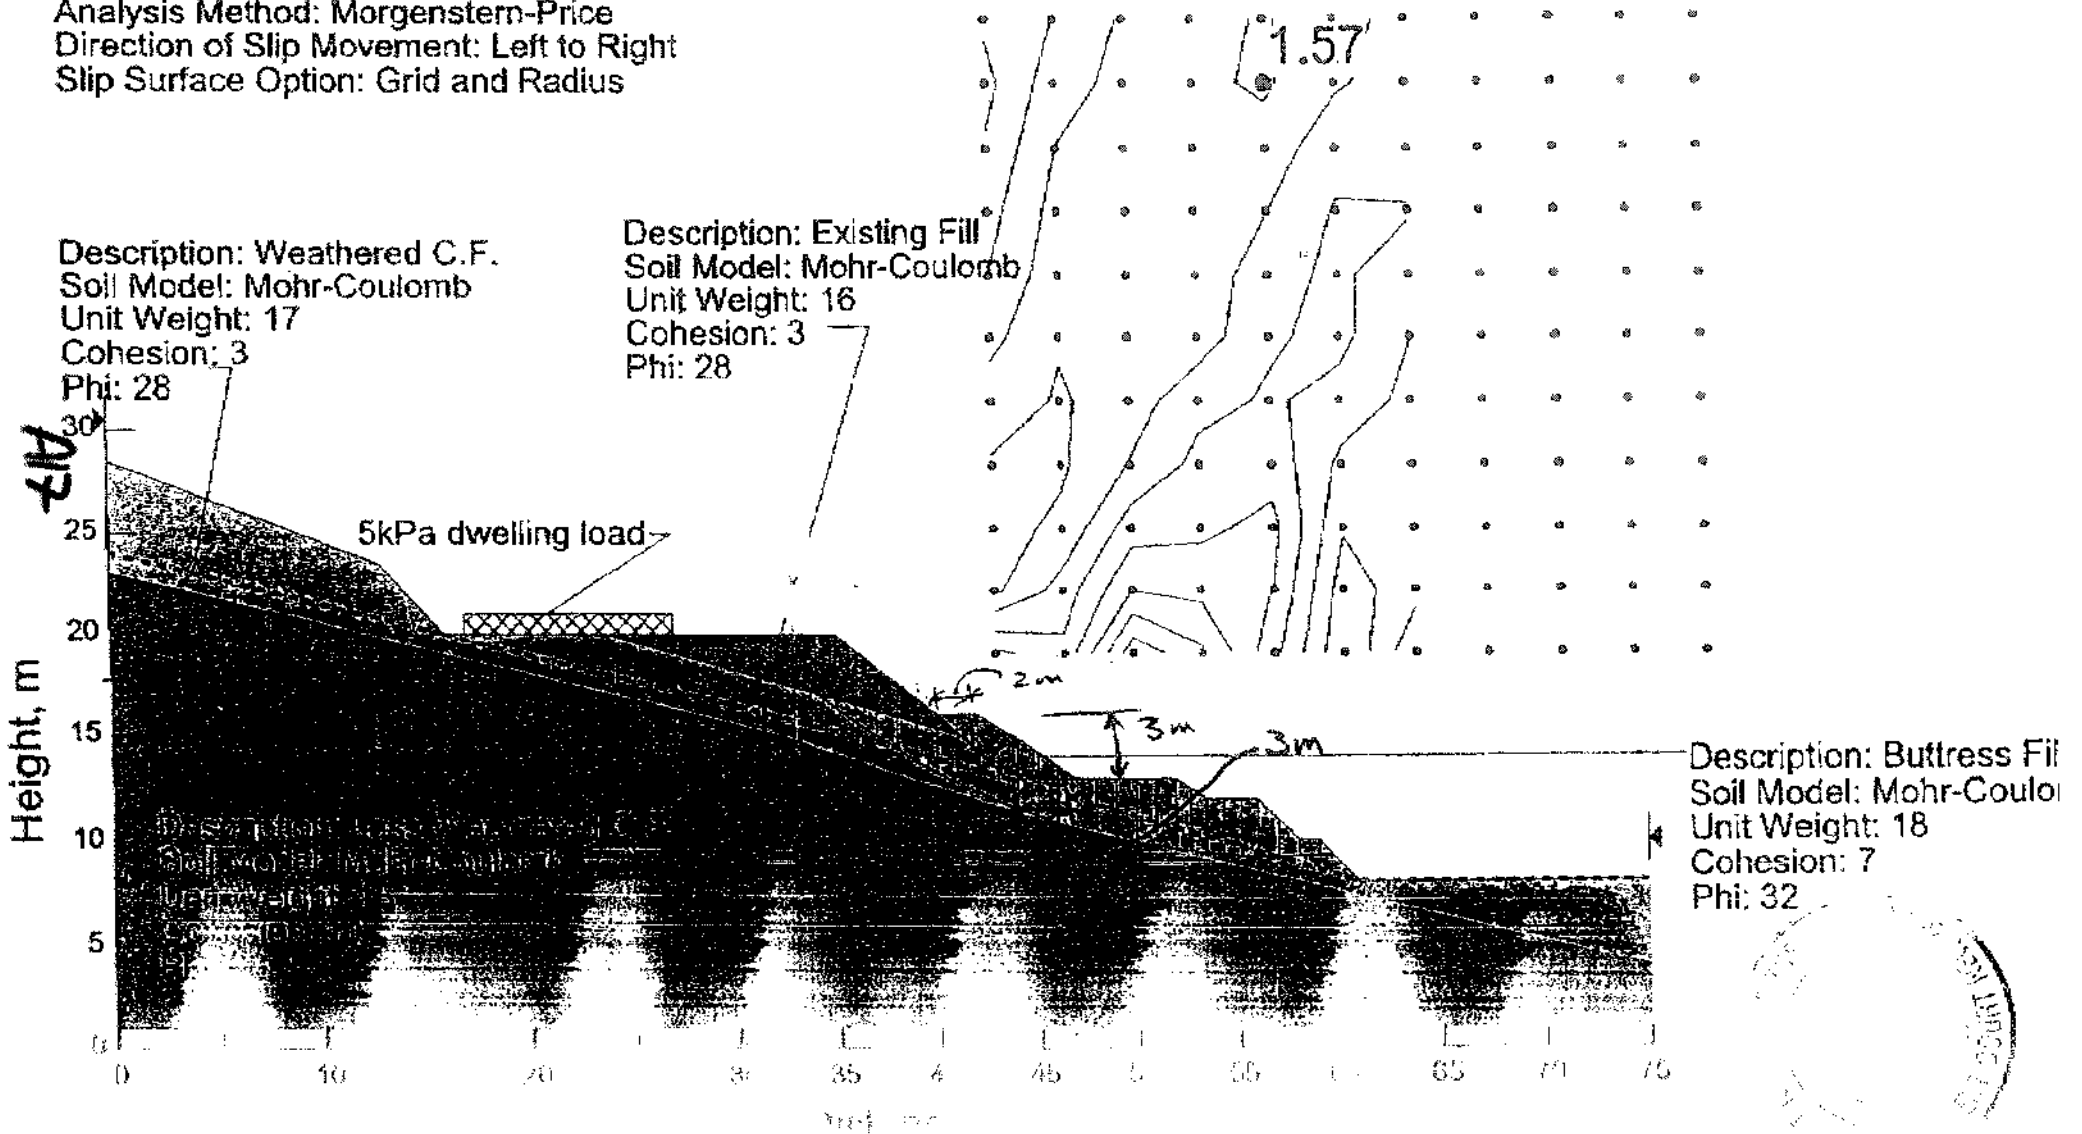
FIGURE 1

Description: 49 Sunnyvale Road, Remediation Works
 Comments: Section A
 File Name: Section A - buttress fill.stz
 Last Saved Date: 29/04/2002
 Last Saved Time: 17:30:53
 Analysis Method: Morgenstern-Price
 Direction of Slip Movement: Left to Right
 Slip Surface Option: Grid and Radius

- 6 The slope stability of the building site has been analysed by Tonkin & Taylor Ltd using Slope/W software. For Section A, the slope immediately below the existing dwelling has a long term FOS > 1.5 when a small, engineered fill buttress is placed at the toe (Figure 1). Analyses of Section B show that the critical surface extending to the eastern wall of the existing structure has a FOS = 1.38 (Figure 2). Our analyses show that an inground retaining wall extending over a 10.5m length (8 piles) would effectively isolate the existing dwelling from downslope instability and increase the Factor of Safety of the building platform to ≥ 1.5 .
- 7 The inground wall was designed using 'Wallap' software. A site sketch (Figure 3) and wall detail (Figure 4) for the design is attached, together with the analysis output (Annexure B1).

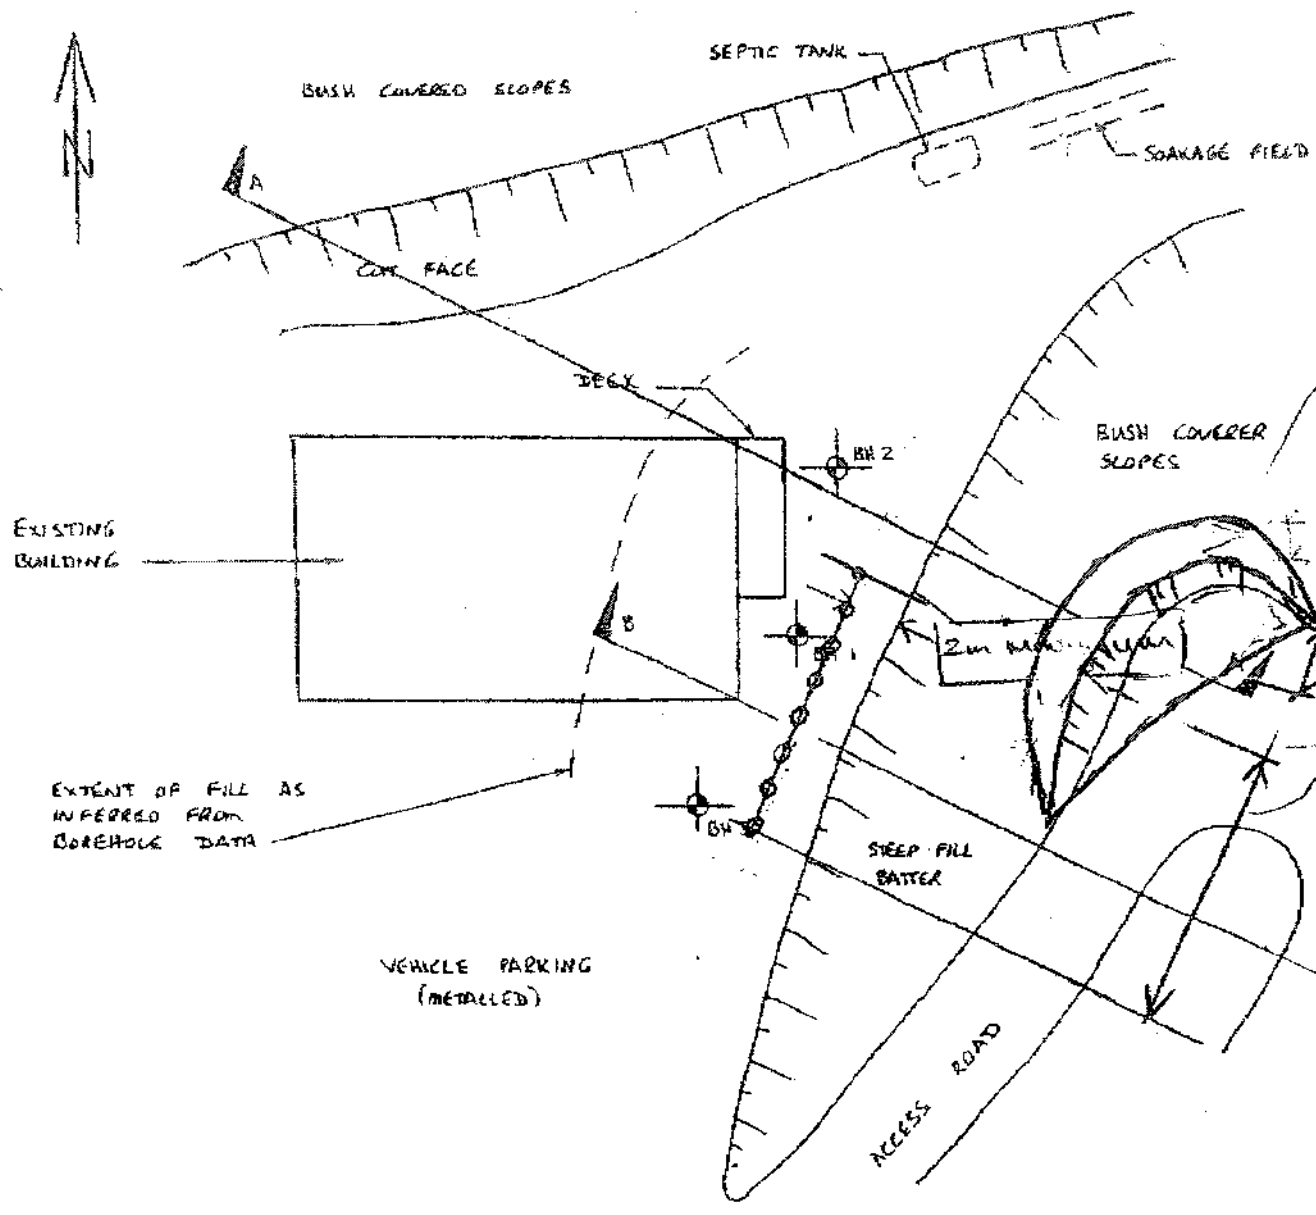
FIGURE 3

BERUM IS 3m HIGH

- 2 To enhance the stability of the building platform, so the long term Factor of Safety (FOS) of the building platform is equal or greater than 1.5, we recommend the construction of a berm and inground retaining structure. This is in general agreement with the scheme proposed at a meeting with Council on 24 April 2002.
- 3 A berm is proposed in the re-entrant corner at the bottom of the access track leading to the platform below the building, see Site Sketch and Section A (Figures 1 and 3).
- 4 The crest of the slope in front of the northeast corner of the building will be stabilised using inground piles (see Figures 3 and 4).
- 5 The above design solution has been subject to initial review by the W.C.C. reviewer, Dr Fendall who also provided the cross section details.

- 9 The inground retaining wall is to comprise 8 No. normal density 275 SED timber poles, concreted into 500mm diameter bored holes at 1.5m centre to centre spacings. The poles are to extend a minimum depth of 6.5m below existing ground level. The locations of the poles are shown on the Site Sketch (Figure 3). Piles must be set back a minimum of 2m from the crest of the batter.

- 12 The 3m high buttress fill should be formed with a minimum 3m wide base and 2m wide crest. The side of the buttress fill should not be steeper than 2.5(H):1(V). Both ends of the fill should taper into the existing batter contours. The locations of the buttress fill is shown on the Site Sketch (Figure 3).
- 13 The construction methodology for the fill buttress is stepped out below:

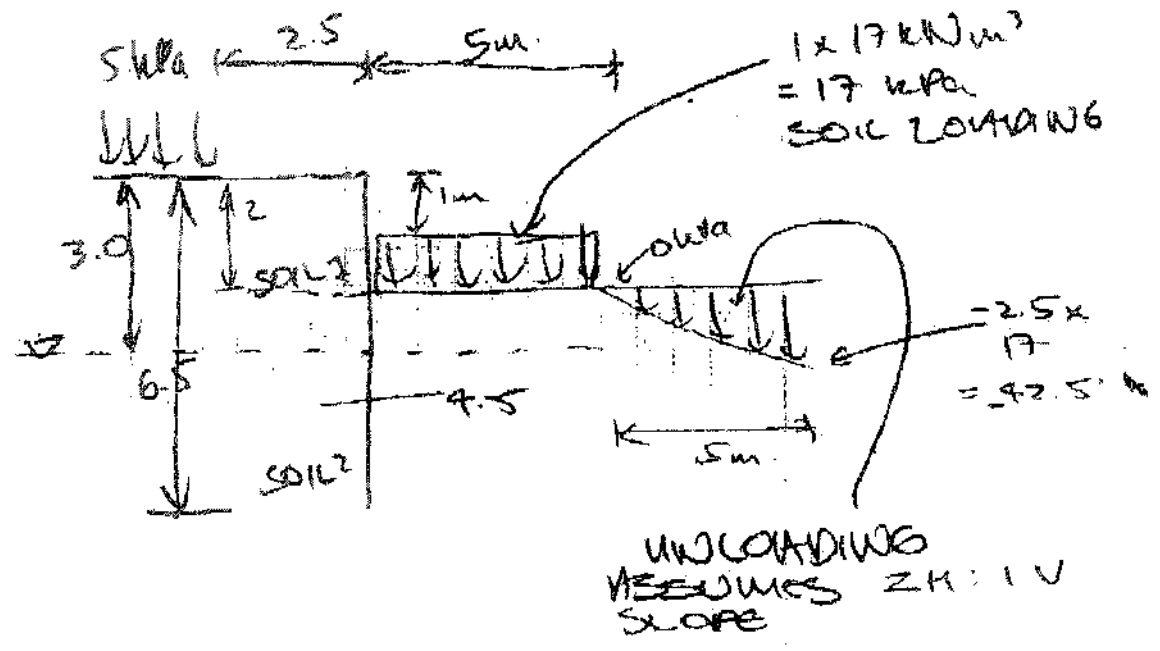
WALL CHECK

MODEL

COMPOSITE SECTION NOT ASSUMED

POLES 275 SED

- 8 We have determined that development of a 1m deep headscarp down slope of the proposed wall, deflections at the top of the wall will be less than 15mm and the wall will achieve a FOS>2.0, while in the extreme event of full evacuation to the base of the fill at 3m the pile capacity will rely on shear transfer between the timber poles and surrounding concrete to achieve a FOS>1.5.

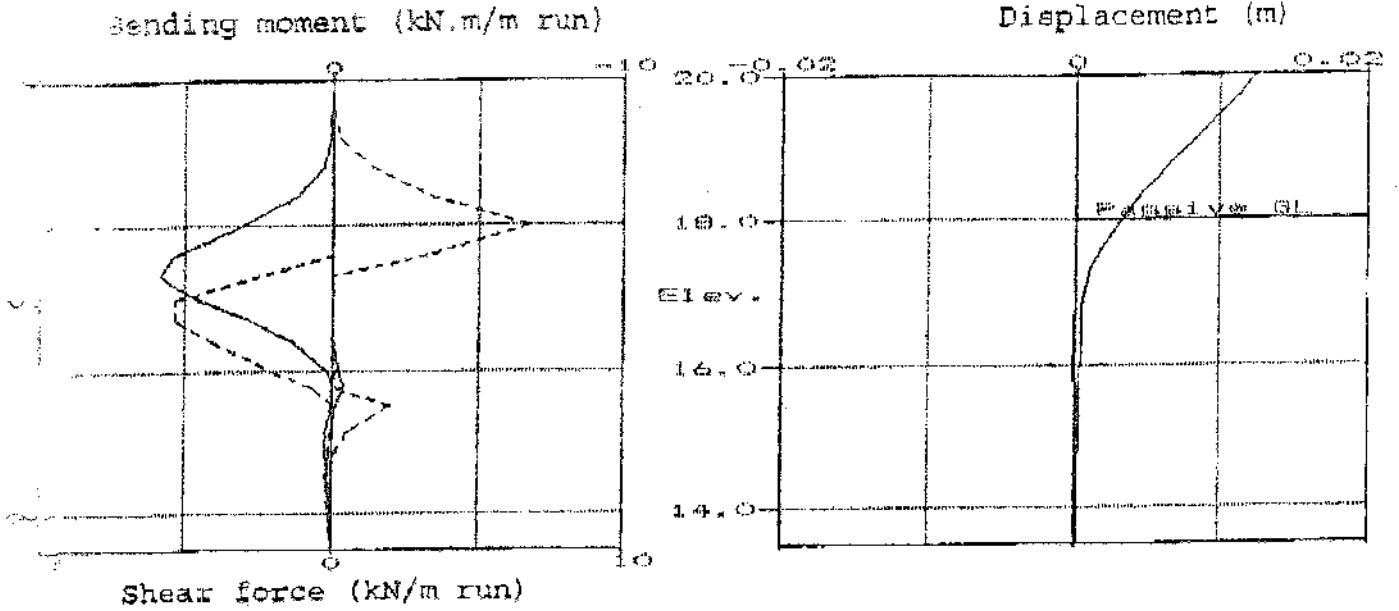
RESULTS

Max moment and displacement envelopes

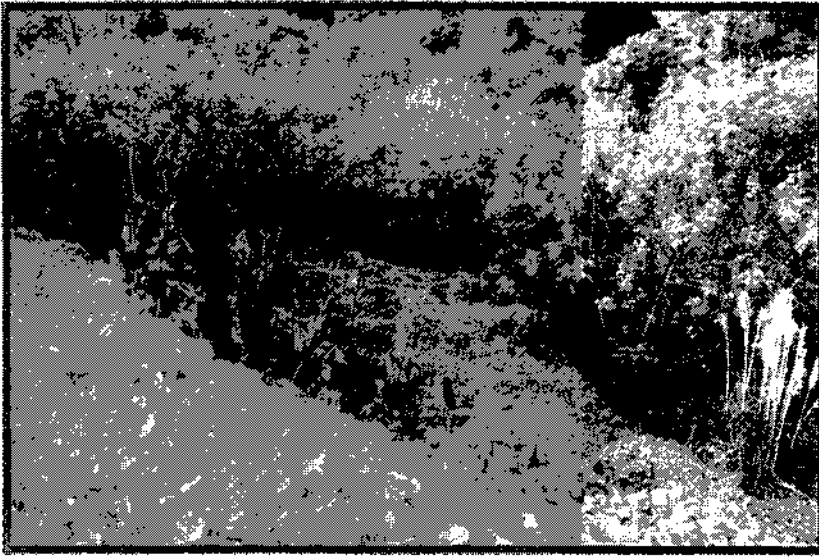
Fig 1. Typical weed cover in gully area

The weed control in this area now requires a more 'heavy duty' approach and probably more widespread spraying to ensure good foliar cover. It is desirable that planting be undertaken as per the recommendations, with appropriate monitoring.

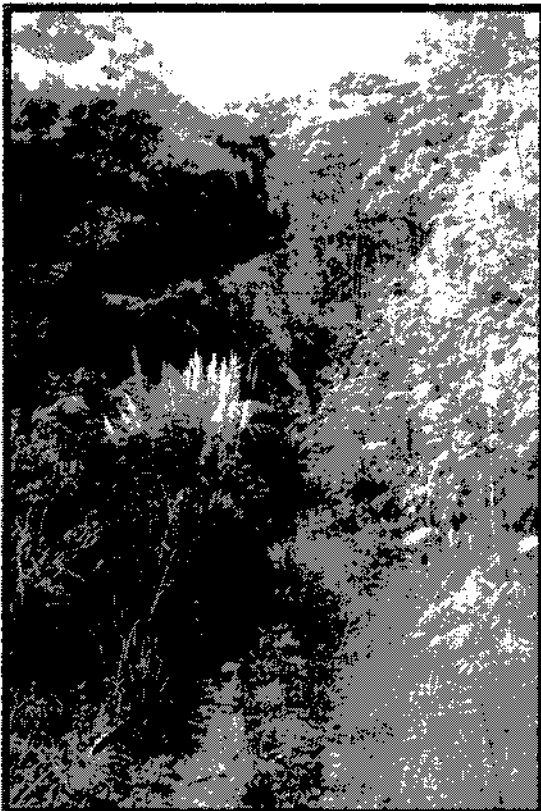
The cut banks at the sides of the formed track have, as expected, grown over with a mix of weeds and native seedlings (refer Fig 3). Pampas (*Cortaderia* spp), wattle (*Acacia* spp), gorse (*Ulex europaeus*) and a mixture of broadleaf weeds have established. Kanuka seedlings, some coprosma and kumerahou have taken root where conditions are favourable, although very steeply-cut faces remain bare.

The culvert which was put in across the Momotu Stream is failing, with deep (10 cm wide) cracks appearing in the track directly above it. A large scour-hole has formed in the stream-bed on the south side of the culvert.

Fig 3. View of track (looking down towards culvert)

The culvert is now of significant concern due to its obvious failure. It is likely that fish-passage has been hindered by the presence of the culvert and the changes in the stream bed and water-flow that have taken place around it. Removing the culvert and reinstating the stream is a fairly major undertaking which would cause environmental damage. I would suggest that this matter requires further discussion with Hugh Fendall.
