Waitakere Greenroof Summary update following March 2008 Assessment

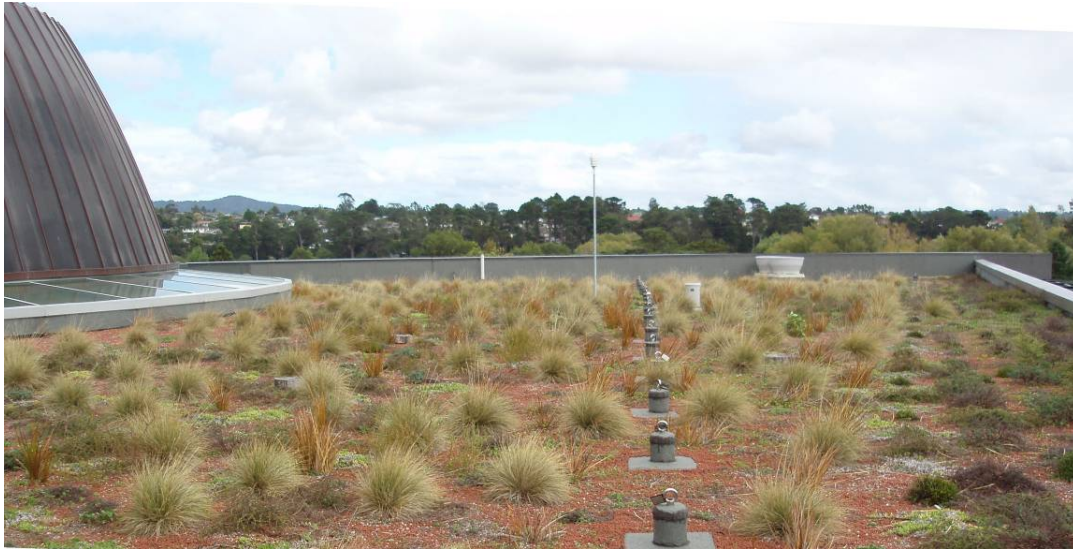
The Waitakere greenroof has performed well over the unusually dry summer of 2007/08 with no supplemental irrigation. Plants died back in February as the roof dried out, turning the roof a dominant brown as leaves senesced (Photo 1). The low groundcovers Mercury Bay weed and Selliera retreated back to the shade provided by both live and dead woody plants (Coprosmas, NZ Daphne and Meuhlenbeckia) and the south side of clumps of NZ iris. NZ iris, tussocks, NZ daphne, sand dune coprosma and nertera have all suffered, with dieback at the tips, outside leaves, and on the sunniest (northern) sides of individual clumps. NZ iceplant continues to be most resistant to drought - planted seedlings continue to spread, and the new seedlings that germinated in autumn 2007 are now well-established in areas with thinnest substrate (harshes growing conditions) and least competition. Calystegia has also weathered the summer well, with its large, green leaves providing relief to the dominant brown vegetation colours. Some plants appear to have died over the summer - these are concentrated on the areas with thinnest substrate and highest exposure to afternoon sun, but mortality won't be able to be assessed until after autumn regrowth, as last summer many plants resprouted from underground roots and stolons, particularly NZ daphne, coprosma, mercury bay weed and selliera.

Photo 1. March 2008 showing summer vegetation colours and dieback

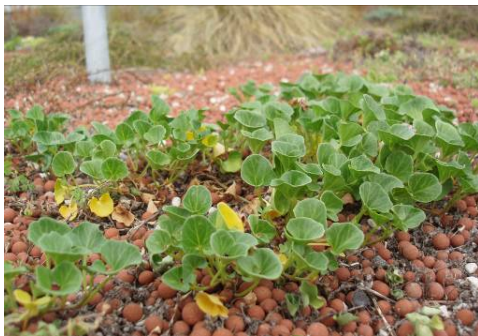
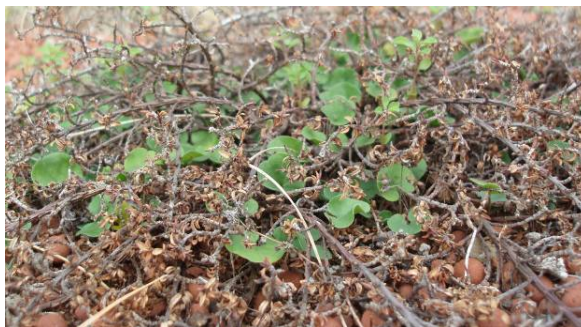
Photo 2. *Calystegia* provides 'green relief' (left) and Mercury Bay weed shelters in the shade of a *Coprosma* with severe dieback.

- planting 30 *Calystegia soldanella*, sand dune convolvulus as PB3/4 into areas of the roof where a 'greener' look would be particularly beneficial (areas with sparse cover or dominant cover of brown-toned plants (libertia, tussock, coprosma)
- Assess need for weeding in mid April. Regenerating plants are vulnerable to damage, so foot traffic should be minimised until May or June if possible, but this needs to be balanced against the benefits of preventing seeding of weed species.

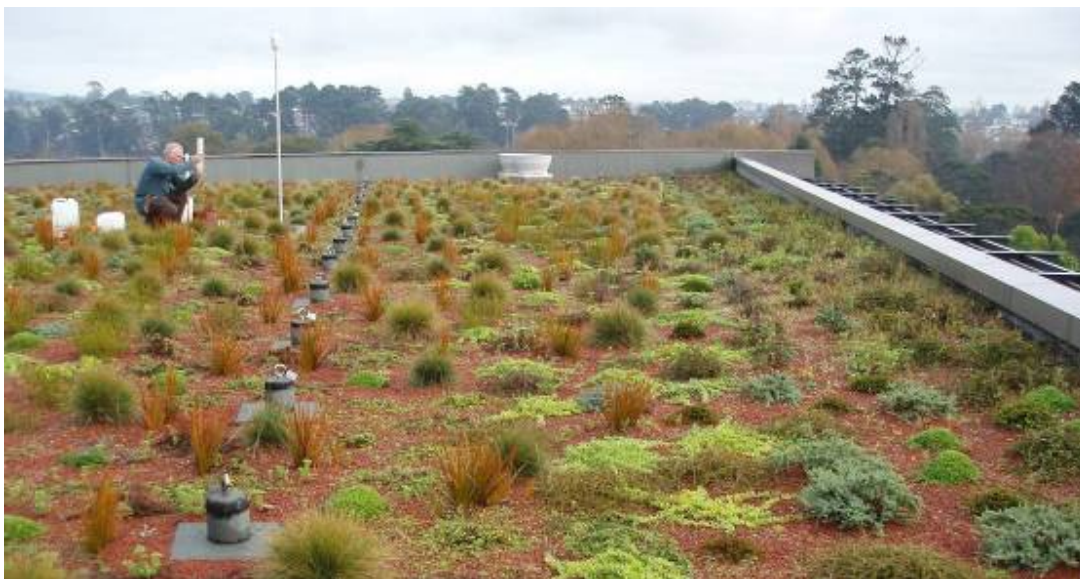
Photo 3. The roof in June 2007 showing peak vegetation cover and winter colours
